**Flood Control Project Maintenance  
Levee Inspections**

## Maintenance Issue Types Only, Levee Inspection Report By Mile - Spring 2018

### Reclamation District No. 2068 Yolo

Waterway	Bank	Unit Miles	Inspection Start/End	Inspector
Unit No. 01 Yolo Bypass	Right	5.48	03/15/2018 03/15/2018	Keith Millard

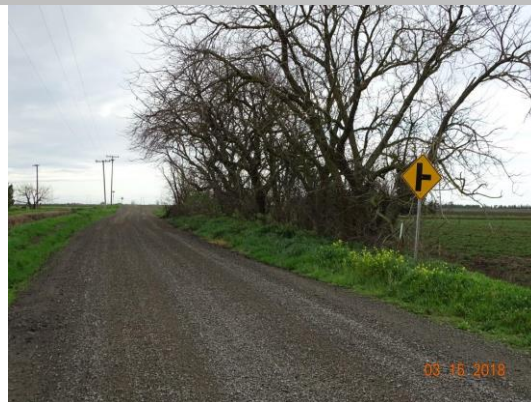
Photo 1 of 1 : SP\_2018\_RD2068\_193\_15\_20180315\_00043.jpg

LM Start	0.40	Rating **	M	Issue No.	15
LM End	0.40	Issue Type +	Ma	Location *	LS
Category	Earthen Levee			GPS Latitude/Longitude	
				Start	End
Item	Trim / Thin Trees			38.402705 °	38.402705 °
				-121.693790 °	-121.693787 °
DWR ID	DWR_RD2068_01_s_2017_15				
Comment Code					
T1 : Trim trees to at least five feet above ground level.					
Inspector Comment					
Trim the tree on the landside shoulder levee mile 0.40.

Trim trees to allow inspection and access to landside slope and toe.

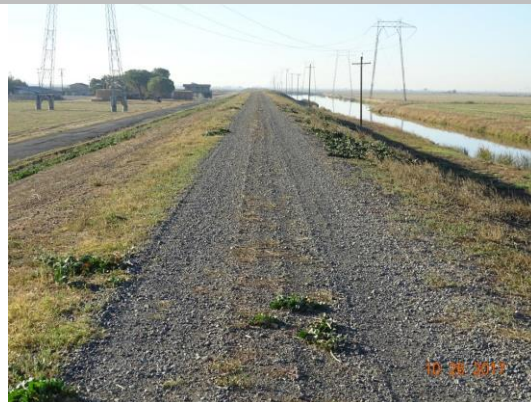
Photo 1 of 1 : SP\_2018\_RD2068\_193\_19\_20180305\_00010.jpg

LM Start	2.69	Rating **	A/W	Issue No.	19
LM End	5.48	Issue Type +	Ma	Location *	CR
Category	Earthen Levee			GPS Latitude/Longitude	
				Start	End
Item	Vegetation			38.369500 °	38.329110 °
				-121.693953 °	-121.694093 °
DWR ID	DWR_RD2068_01_s_2017_19				
Comment Code					
V9 : Keep the crown roadway free of vegetation.					
Inspector Comment					
Crown is currently free of vegetation.

Crown is currently free of vegetation.

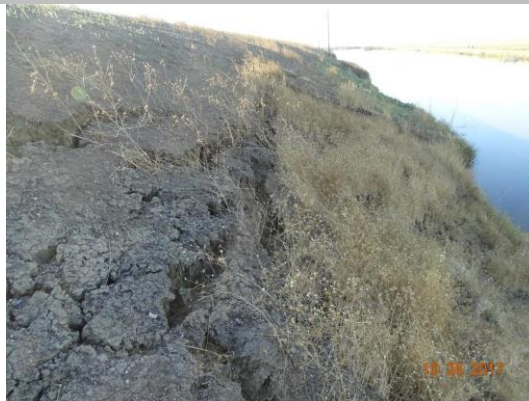
Photo 2 of 2 : SP\_2018\_RD2068\_193\_20\_20180305\_00012.jpg

LM Start	3.16	Rating **	A/W	Issue No.	20 (cont)	
LM End	3.19	Issue Type +	Ma	Location *	LS	
Category	Earthen Levee			GPS Latitude/Longitude		
				Start		End
Item	Slope Stability			38.362765 °		38.362278 °
				-121.694040 °		-121.694050 °
DWR ID	DWR_RD2068_01_s_2017_20					
Comment Code						
S1 : Repair slope instability.						
Inspector Comment						
Repair the slope instability.

Repair the slope instability.

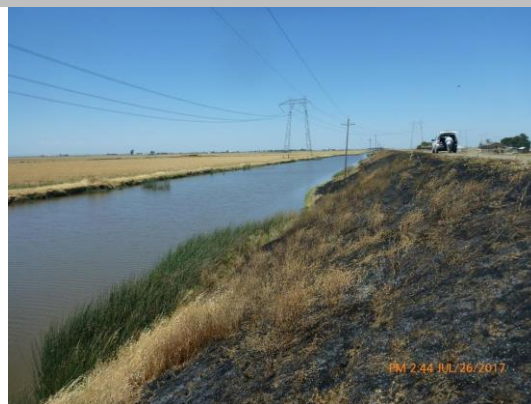
Photo 1 of 3 : SP\_2018\_RD2068\_193\_16\_20180305\_00001.jpg

LM Start	3.30	Rating **	A/W	Issue No.	16
LM End	3.31	Issue Type +	Ma	Location *	
Category	Supplemental			GPS Latitude/Longitude	
				Start	End
Item	2017 Storm Damage			38.360700 °	38.360600 °
				-121.694200 °	-121.694200 °
DWR ID	DWR_RD2068_01_f_2017_16				
Comment Code					
Inspector Comment					
Levee Evaluation Comments					
Description:The damage consists of scour, cracking, and sloughing of the lower and mid landside levee slope approximately 39 feet in length along the west (right) bank of Shag Slough (Yolo Bypass). See attached pages for photos.					
Site ID No:457					
Site Designation:LMA-284					
Repair Type: Stability					
Rating:Serious					
Field Date:7/26/2017					
Notes: combined with LMA-283. Combined site length 430'.

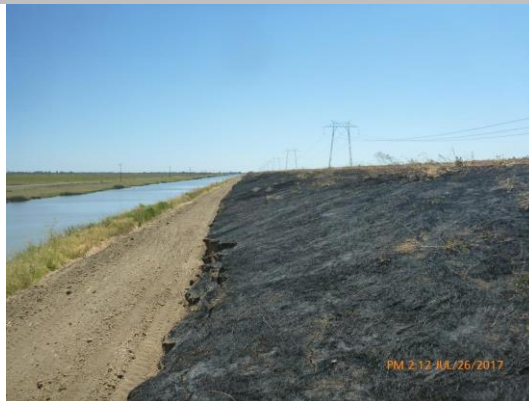
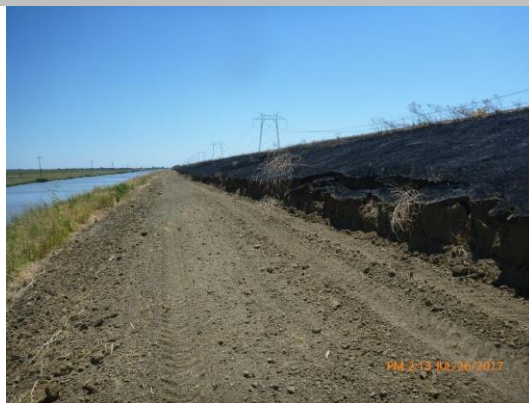
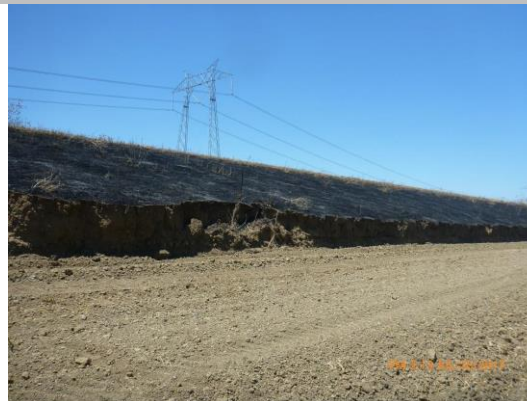
LM Start	3.36	Rating **	A/W	Issue No.	17
LM End	5.23	Issue Type +	Ma	Location *	WS
Category	Supplemental			GPS Latitude/Longitude	
				Start	End
Item	2017 Storm Damage			38.359900 °	38.332700 °
				-121.693800 °	-121.693700 °
DWR ID	DWR_RD2068_01_f_2017_17				
Comment Code					
Inspector Comment					
Levee Evaluation Comments					
Description:The damage consists of scour and sloughing of the lower waterside levee slope approximately 9,950 feet in length along the west (right) bank of Shag Slough (Yolo Bypass). See attached pages for photos.					
Site ID No:459					
Site Designation:LMA-286					
Repair Type: Stability					
Rating:Area of Concern					
Field Date:7/26/2017					
Notes:

LM Start	3.36	Rating **	A/W	Issue No.	17 (cont)
LM End	5.23	Issue Type +	Ma	Location *	WS
Category	Supplemental			GPS Latitude/Longitude	
				Start	End
Item	2017 Storm Damage			38.359900 °	38.332700 °
				-121.693800 °	-121.693700 °
DWR ID	DWR_RD2068_01_f_2017_17				
Comment Code					
Inspector Comment					
Levee Evaluation Comments					
Description:The damage consists of scour and sloughing of the lower waterside levee slope approximately 9,950 feet in length along the west (right) bank of Shag Slough (Yolo Bypass). See attached pages for photos.					
Site ID No:459					
Site Designation:LMA-286					
Repair Type: Stability					
Rating:Area of Concern					
Field Date:7/26/2017					
Notes:

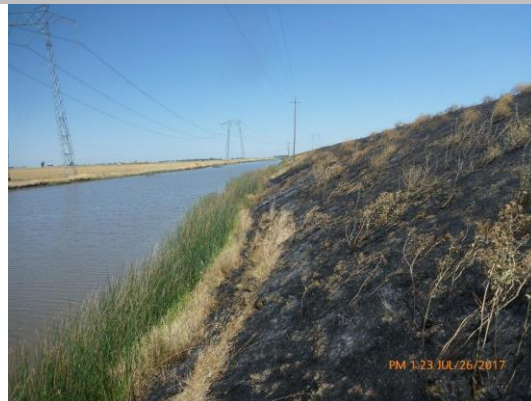
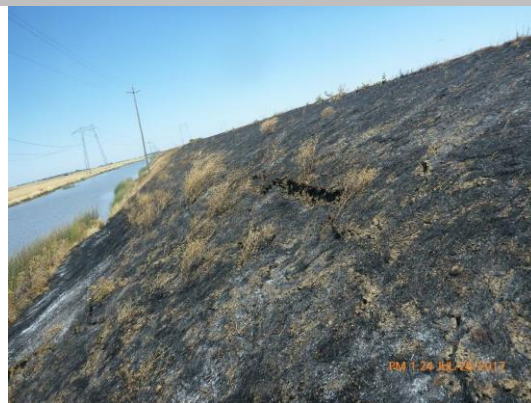
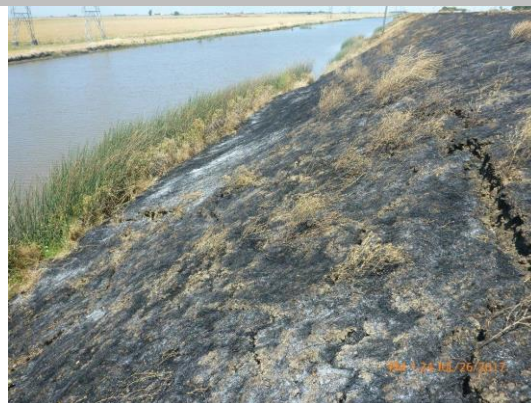
LM Start	3.38	Rating **	A/W	Issue No.	18
LM End	3.39	Issue Type +	Ma	Location *	
Category	Supplemental			GPS Latitude/Longitude	
				Start	End
Item	2017 Storm Damage			38.359500 °	38.359400 °
				-121.694200 °	-121.694200 °
DWR ID	DWR_RD2068_01_f_2017_18				
Comment Code					
Inspector Comment					
Levee Evaluation Comments					
Description:The damage consists of scour of the lower landside levee slope approximately 32 feet in length along the west (right) bank of Shag Slough (Yolo Bypass). See attached pages for photos.					
Site ID No:460					
Site Designation:LMA-287					
Repair Type: Stability					
Rating:Serious					
Field Date:7/26/2017					
Notes: levee slope is heavily impacted from deep slope cracks and lack of levee slope support from the toe

LM Start	3.38	Rating **	A/W	Issue No.	18 (cont)	
LM End	3.39	Issue Type +	Ma	Location *		
Category	Supplemental			GPS Latitude/Longitude		
				Start	End	
Item	2017 Storm Damage			38.359500 °	38.359400 °	
				-121.694200 °	-121.694200 °	
DWR ID	DWR_RD2068_01_f_2017_18					
Comment Code						
Inspector Comment						
Levee Evaluation Comments						
Description:The damage consists of scour of the lower landside levee slope approximately 32 feet in length along the west (right) bank of Shag Slough (Yolo Bypass). See attached pages for photos.						
Site ID No:460						
Site Designation:LMA-287						
Repair Type: Stability						
Rating:Serious						
Field Date:7/26/2017						
Notes: levee slope is heavily impacted from deep slope cracks and lack of levee slope support from the toe

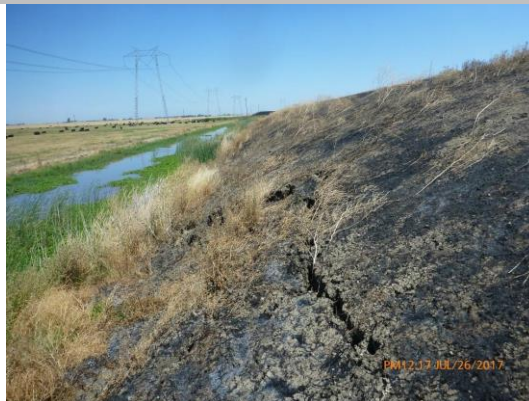
Photo 3 of 3 : SP\_2018\_RD2068\_193\_27\_20180305\_00015.jpg

LM Start	3.73	Rating **	A/W	Issue No.	27 (cont)	
LM End	3.74	Issue Type +	Ma	Location *		
Category	Supplemental			GPS Latitude/Longitude		
				Start	End	
Item	2017 Storm Damage			38.354500 °	38.354400 °	
				-121.694000 °	-121.694000 °	
DWR ID	DWR_RD2068_01_f_2017_27					
Comment Code						
Inspector Comment						
Levee Evaluation Comments						
Description:The damage consists of scour, cracking, and sloughing of the lower landside levee slope approximately 47 feet in length along the west (right) bank of Shag Slough (Yolo Bypass). See attached pages for photos.						
Site ID No:462						
Site Designation:LMA-289						
Repair Type: Stability						
Rating:Serious						
Field Date:7/26/2017						
Notes: 2' feet vertical cut on waterside levee toe from wavewash; site combined with LMA- 288 in field.

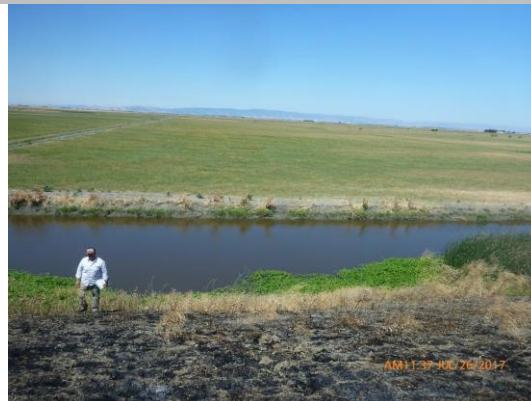
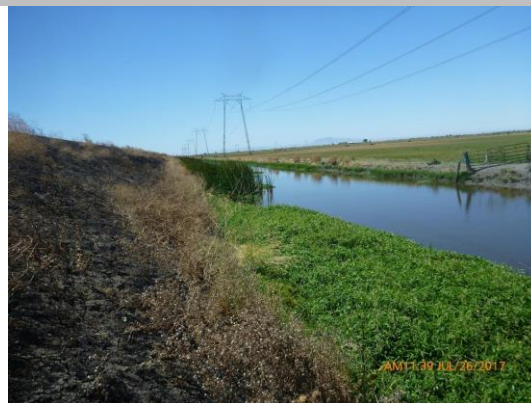
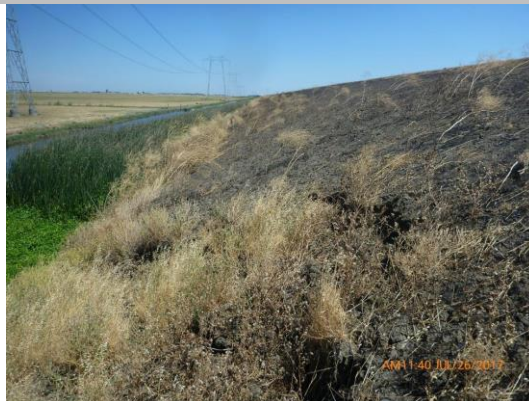
LM Start	4.30	Rating **	A/W	Issue No.	28
LM End	4.31	Issue Type +	Ma	Location *	
Category	Supplemental			GPS Latitude/Longitude	
				Start	End
Item	2017 Storm Damage			38.346200 °	38.346100 °
				-121.694000 °	-121.694000 °
DWR ID	DWR_RD2068_01_f_2017_28				
Comment Code					
Inspector Comment					
Levee Evaluation Comments					
Description:The damage consists of scour, cracking, and sloughing of the lower landside levee slope approximately 30 feet in length along the west (right) bank of Shag Slough (Yolo Bypass). See attached pages for photos.					
Site ID No:463					
Site Designation:LMA-290					
Repair Type: Stability					
Rating:Serious					
Field Date:7/26/2017					
Notes: 3' feet vertical cut at waterside levee toe from wavewash

LM Start	4.30	Rating **	A/W	Issue No.	28 (cont)	
LM End	4.31	Issue Type +	Ma	Location *		
Category	Supplemental			GPS Latitude/Longitude		
				Start	End	
Item	2017 Storm Damage			38.346200 °	38.346100 °	
				-121.694000 °	-121.694000 °	
DWR ID	DWR_RD2068_01_f_2017_28					
Comment Code						
Inspector Comment						
Levee Evaluation Comments						
Description:The damage consists of scour, cracking, and sloughing of the lower landside levee slope approximately 30 feet in length along the west (right) bank of Shag Slough (Yolo Bypass). See attached pages for photos.						
Site ID No:463						
Site Designation:LMA-290						
Repair Type: Stability						
Rating:Serious						
Field Date:7/26/2017						
Notes: 3' feet vertical cut at waterside levee toe from wavewash

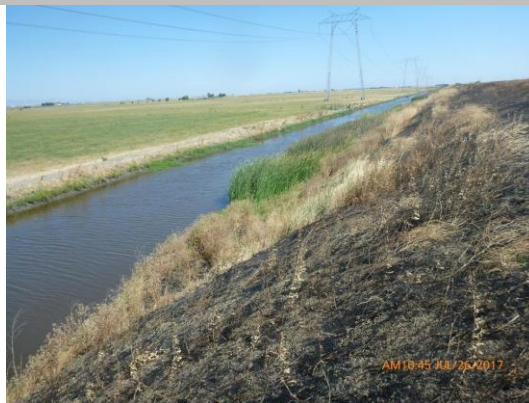
Photo 1 of 3 : SP\_2018\_RD2068\_193\_29\_20180305\_00019.jpg

LM Start	4.39	Rating **	A/W	Issue No.	29
LM End	4.40	Issue Type +	Ma	Location *	
Category	Supplemental			GPS Latitude/Longitude	
				Start	End
Item	2017 Storm Damage			38.344900 °	38.344800 °
				-121.694000 °	-121.694000 °
DWR ID	DWR_RD2068_01_f_2017_29				
Comment Code					
Inspector Comment					
Levee Evaluation Comments					
Description:The damage consists of scour, cracking, and sloughing of the lower landside levee slope approximately 30 feet in length along the west (right) bank of Shag Slough (Yolo Bypass). See attached pages for photos.					
Site ID No:464					
Site Designation:LMA-291					
Repair Type: Stability					
Rating:Serious					
Field Date:7/26/2017					
Notes: 2' feet vertical cut at waterside levee toe from wavewash

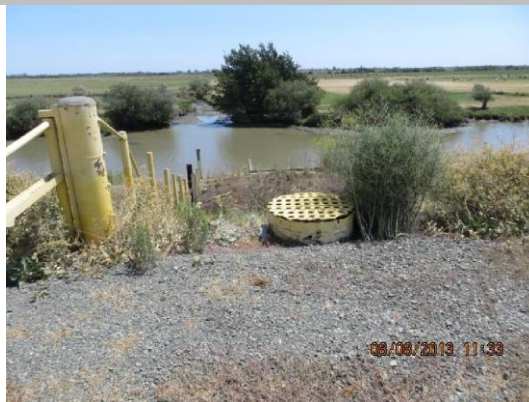
Photo 1 of 3 : UCIP\_SP\_2018\_17479\_29574.jpg

Comment Code					
Inspector Comment					
FS_ID:17479					
DS_ID:19343					
EP_NO: 2359					
Repair Type: No Action Needed					
Crossing Status: Found					
UCIP Comments:					
FIELD_STRUCT_DESC: 1 of 3: 36-inch steel drainage pipe through the levee, 3 feet below the crown. Siphon breaker in a 36-inch steel riser on the waterside (WS) shoulder. Flap gate in a 10-foot by 20-foot concrete outlet box at the WS toe. Pump in pump house on pier on the landside (LS). (Permit No. 2359, 1956 - Reclamation District No. 2068).					
[Additional Reference(s): DWR Levee Log, 1992. USACE Sacramento O&M Manual 109, April 1962, (HLM 5.48)].					
FS Date: 8/8/2013

Siphon breaker in 36-inch diameter steel riser on WS shoulder.

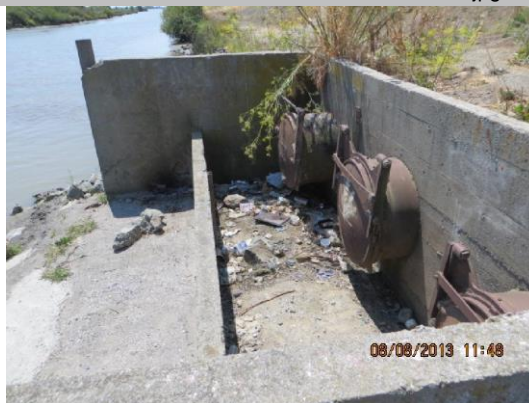
Photo 3 of 3 : UCIP\_SP\_2018\_17480\_29576.jpg

LM Start	5.46	Rating **	A/W	Issue No.	36 (cont)	
LM End	5.46	Issue Type +	Ma	Location *		
Category	Supplemental			GPS Latitude/Longitude		
				Start	End	
Item	DWR UCIP LMA Responsibility			38.329397°	38.329397°	
				-121.694076°	-121.694076°	
DWR ID						
Comment Code						
Inspector Comment						
FS_ID:17480 DS_ID:19342 EP_NO: 2359 Repair Type: No Action Needed Crossing Status: Found UCIP Comments: FIELD_STRUCT_DESC: 2 of 3: 42-inch steel drainage pipe through the levee, 3 feet below the crown. Siphon breaker in a 36-inch steel riser on the waterside (WS) shoulder. Flap gate in a 10-foot by 20-foot concrete outlet box at the WS toe. Pump in pump house on pier on the landside (LS). (Permit No. 2359, 1956 - Reclamation District No. 2068). [Additional Reference(s): DWR Levee Log, 1992. USACE Sacramento O&M Manual 109, April 1962, (HLM 5.48)]. FS Date: 8/8/2013

Flap gate in 10'X20' concrete outlet box at WS toe.

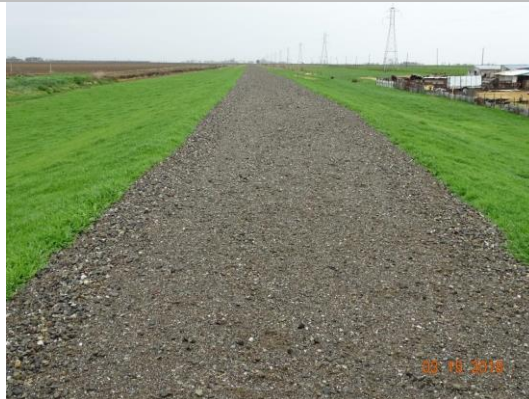
Photo 1 of 1 : SP\_2018\_RD2068\_194\_11\_20180315\_00012.jpg

LM Start	0.01	Rating **	A/W	Issue No.	11
LM End	1.85	Issue Type +	Ma	Location *	CR
Category	Earthen Levee			GPS Latitude/Longitude	
				Start	End
Item	Vegetation			38.358313 °	38.382542 °
				-121.740385 °	-121.730262 °
DWR ID	DWR_RD2068_02_s_2017_11				
Comment Code					
V9 : Keep the crown roadway free of vegetation.					
Inspector Comment					
Crown is free of vegetation.

Lack of crown vegetation looking north from LM 1.02.
